Minerals Inspection Report

Mine Name: Talons Cove	Permit Number: M/49/0091	Mine Status: Active
Operator Name: TM Crushing	Inspection Date: 9/7/2016	Permit Fees: Paid
Inspector(s): A. Abate	Inspection Time: 8:00 AM	Bond Amount: \$1,800,000
Attendee(s): Nick Baird, Operator	Weather: Clear 80s	Bond Escalation:
Inspection Purpose: Large Mine Permit Review Field Inspection		Prior Inspection: 1/15/2015

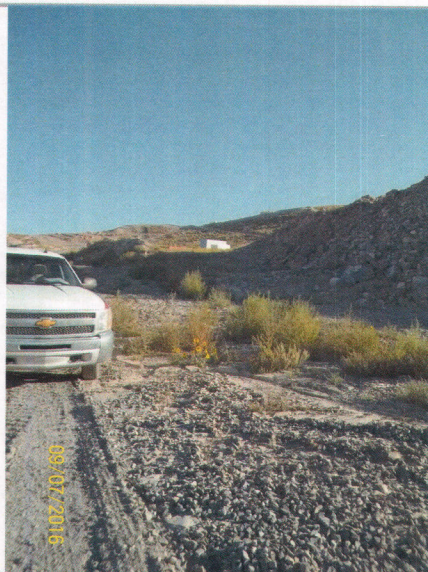
3.	<i>Protection of Drainages/Erosion Control</i>	<input checked="" type="checkbox"/>	<input type="checkbox"/>
The sediment retention areas that are on either side of the primary road as you enter the active mining area were inspected. The east pond did not have a berm separating it from the primary road in order to better control runoff flowing down the hill. This was brought to the operators attention. The ponds appear to be adequately sized to have the capacity to manage the amount of stormwater generated at this property.

The berm along the west side of the east sediment pond needs to be built up.

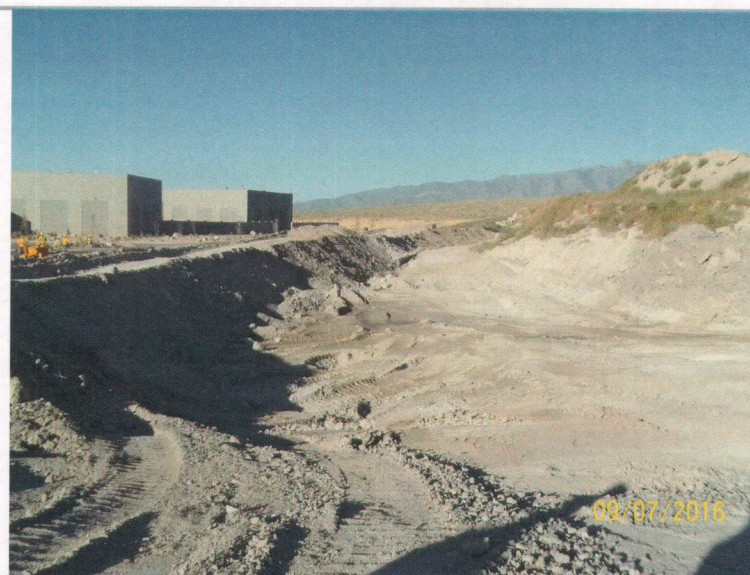
8.	<i>Soils</i>	<input checked="" type="checkbox"/>	<input type="checkbox"/>
Topsoil berms were observed along the southeast and the western side of the permit area. The topsoil berms (with the exception of the ones shown on the northeast portion of the site were in the same locations as presented on the maps in the Notice. The berms in the northeast area have not been constructed because mining has not started in that area.

View of the west sediment pond looking west. Topsoil berm is shown towards the background.

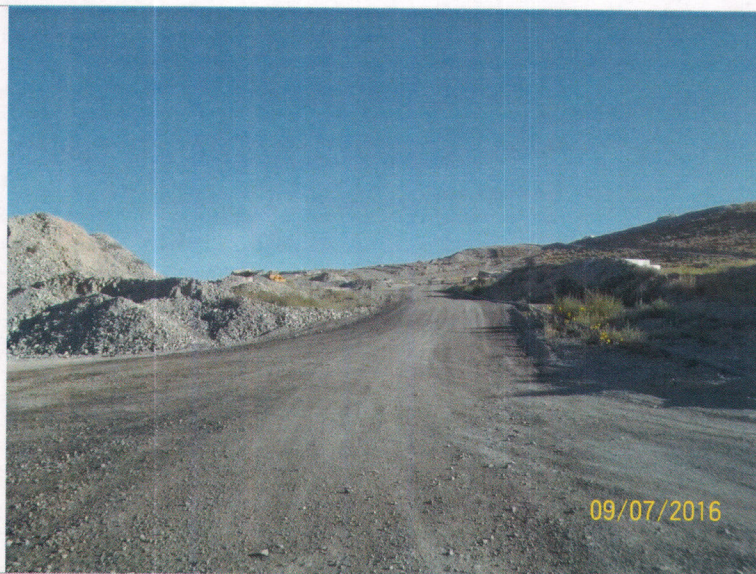
5.	<i>Roads (maintenance, surfacing, dust control, safety)</i>	<input checked="" type="checkbox"/>	<input type="checkbox"/>
Roads looked well maintained. The primary road was recently paved in order to mitigate dust generation.

Primary road into the mine (now paved).

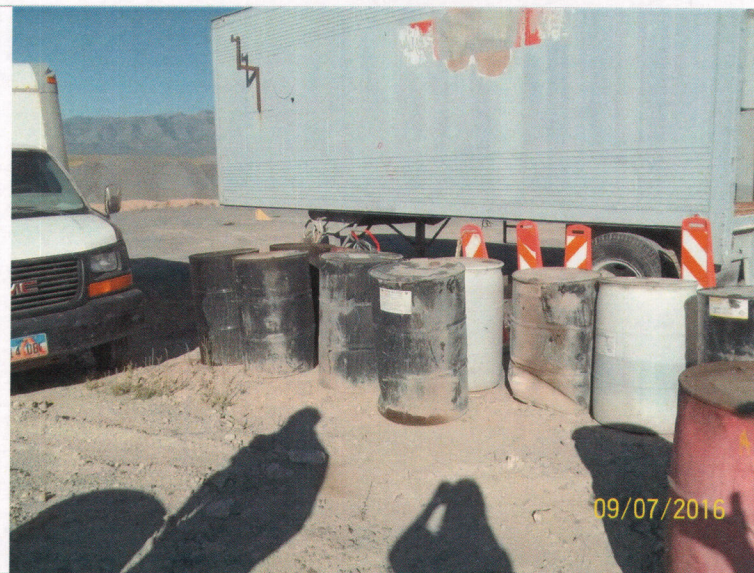
4.	<i>Deleterious Material</i>	<input checked="" type="checkbox"/>	<input type="checkbox"/>
Approximately 10 55-gallon drums were located in an area near some freight containers that the operator identified as a maintenance area. The drums were not in an enclosed containment area and were not on pallets. This was brought to the operators attention.

Area of 55-gallon drums, needs to be secured properly in a containment area.
